Manhole Inspection Summary

Manhole # S23GG1017MH

Insp Date: **12/7/06 1:06 PM**

Location Address: **4118 BUENA VISTA AVE**

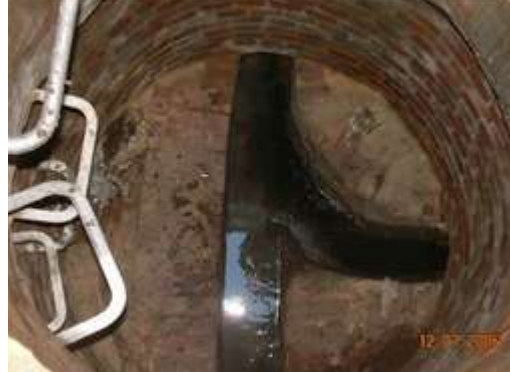
Top View

Evidence of surcharge - Bench debris.
Channel debris.

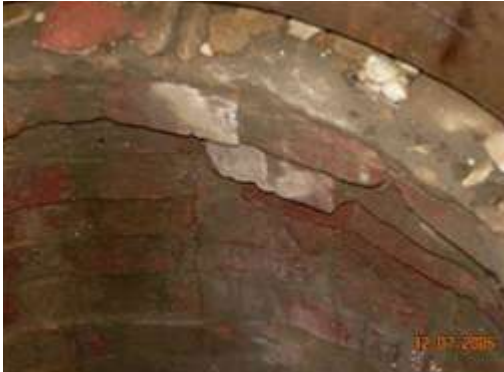
Defect

☒ **Leaks**

Condition: ☐ Sound ☐ Cracked ☐ Root Intrusion ☐ Loose Brick ☒ **Deteriorated**

Infiltration: ☐ None ☒ **Joint** ☐ Cracks ☒ **Mortar** ☐ Roots ☐ Wall

Infiltration: ☐ None ☐ Joint ☐ Cracks ☒ **Mortar** ☐ Roots ☒ **Wall**

Frame leaks. Frame offset. Adjustment
deterioration and infiltration. Corbel
infiltration.

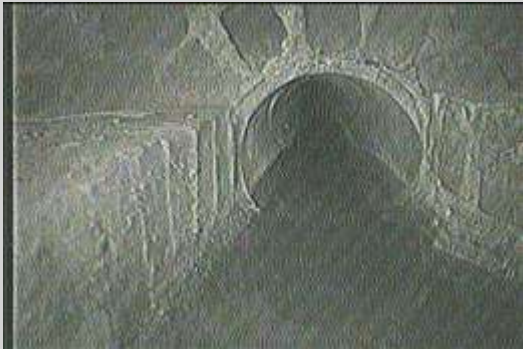
8 in. Circular Gravity Sewer Pipe Out @ 12 O'Clock

Infiltration: **Evidence** Pipe Seal Cond: **Cracked**

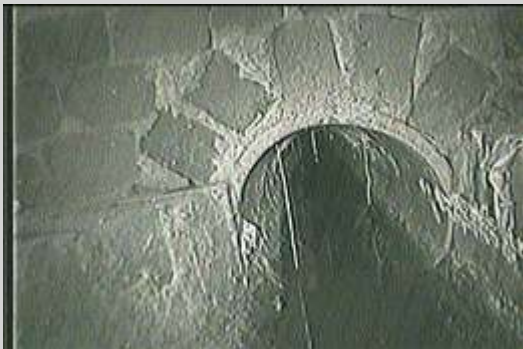
8 in. Circular Gravity Sewer Pipe In @ 3 O'Clock

Deposits: ☐ None ☐ Mud ☐ Sludge ☐ Debris ☒ Grease

Silt Depth: **0** (in.) Deposits Extent: **Light**

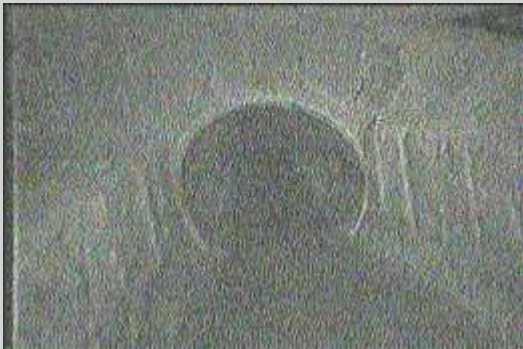
8 in. Circular Gravity Sewer
Pipe In @ 6 O'Clock

Deposits: ☐ None ☐ Mud ☐ Sludge ☐ Debris ☒ **Grease**

Silt Depth: **0** (in.) Deposits Extent: **Light**
